## Tractor Operator was Killed in an Overturn while Moving a Sandblasting Trailer

### SUMMARY

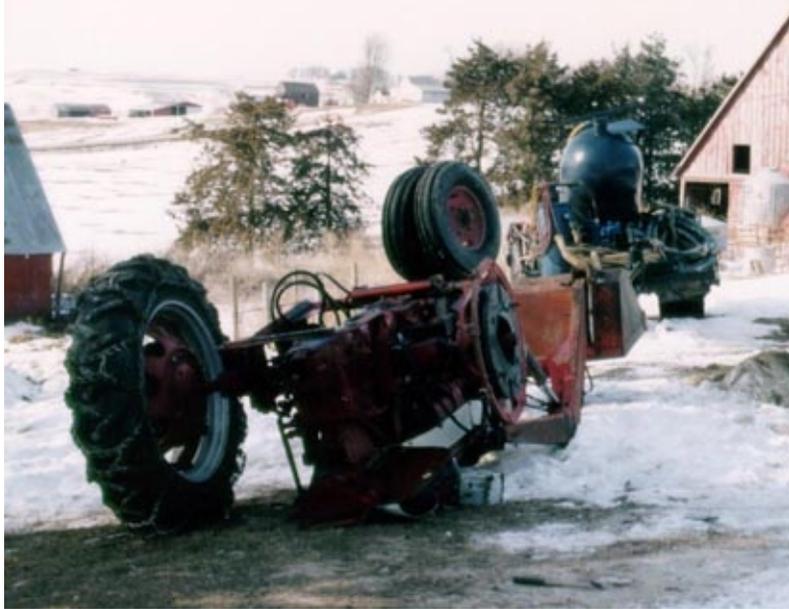
During the winter of 1999 a man was killed while operating a narrow-front tractor at a rural business location in Iowa. The man was the owner of a sand blasting company and was in the process of moving a sandblasting trailer on his acreage. This homemade sandblasting trailer had previously been filled with sand by an employee who then parked the trailer in an undesirable location, slightly downhill from the main driveway. The trailer for the sandblaster had a high-mounted tongue, and the support jack for this trailer was in an extended position, therefore it was impossible to hook

the trailer directly to the tractor draw bar. The man attached a chain from the trailer tongue to the front-end loader bucket. He lifted the tongue off the ground, then tried to back uphill with the tractor. The sand blasting trailer was full of sand and very heavy. It had snowed recently, and the victim was having difficulty getting sufficient traction while backing uphill in this position. Realizing he needed more pulling power, he attached a 50-foot chain from the tractor draw bar to the rear of a compressor truck used in the business. The man's wife drove the truck, following hand signals from her husband. The truck was positioned on the entrance road to the acreage, slightly at an angle from the tractor and the sandblasting trailer. As they began to pull and move ahead, the truck turned slightly to its right down the driveway. This created a situation where the chains were pulling the tractor at an angle creating sideways forces at both attachment points. These forces caused the tractor to overturn to its left side, killing the operator underneath. The tractor did not have a Roll Over Protective Structure (ROPS).

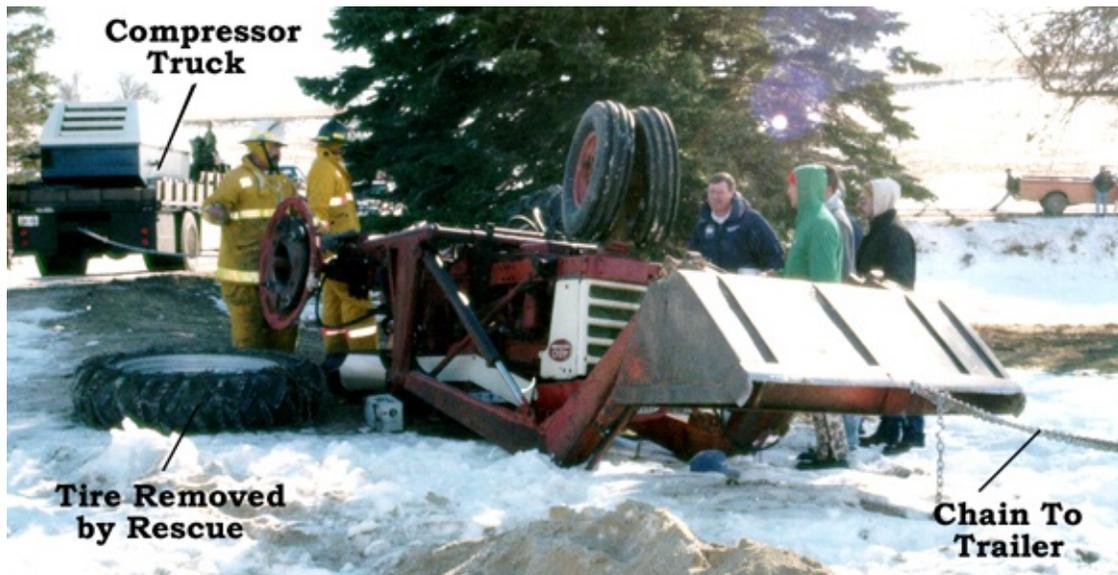
## Photo 2

**Discussion:** Towing or pulling heavy equipment can become hazardous if the powered vehicle is pulling at an angle or if attachment points are high off the ground, thus increasing the risk of overturn. In this case the tractor front attachment point was the edge of the front-end loader (see [Photo 2](#)), which was approximately 1.2 m (4') off the ground. Supporting the heavy trailer with the loader shifted some weight from the back wheels to the front wheels, which reduced the tractor's pulling power and compromised stability due to the narrow front design. Initially the tractor and the sandblasting trailer were aligned, but after the truck started to pull and move down the driveway at an angle, significant sideways forces to the front and rear of the tractor were created. The combination of this changed angle, the tractor weight shifted to the front, the high front attachment point, narrow front wheels, and the sloping ground to the side of the tractor were accumulative factors sufficient to overturn the tractor to its left side. Even if visual communication between the two drivers was maintained, there would likely not have been sufficient time to react and prevent the sudden overturn. Pulling machinery at an angle should be avoided, and attachment points should be kept low, below or near axle level.

**Recommendation #1:** *To avoid overturns, operators of heavy equipment should pay special attention to the attachment points and direction of pull while towing other equipment.*

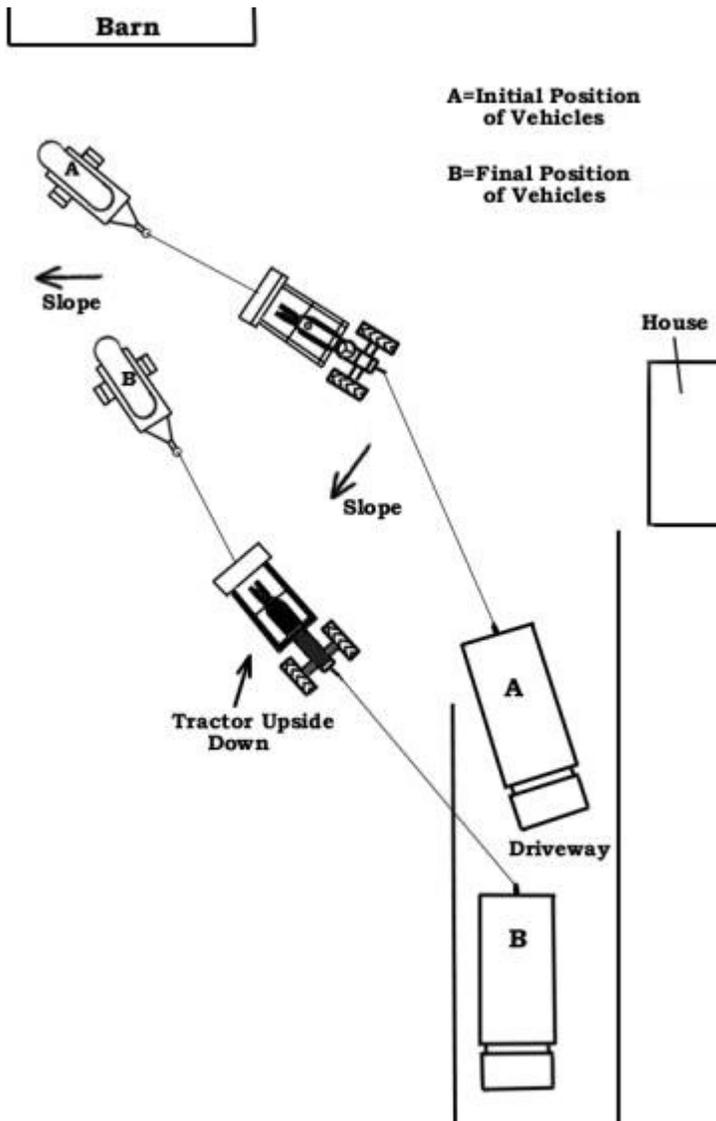
It had recently snowed and there were snow drifts around the trailer, therefore the sloped area where the trailer was parked was quite slippery. Normally the trailer was moved using the compressor truck, but due to the slope and the weather, the victim did not want to risk getting the truck stuck in the snow. The height of the trailer tongue was about 0.75 meters (2' 6"), which matched the compressor truck hitch point. The tongue of the trailer was supported by a heavy-duty, screw-type jack. The tongue was not made to fit the tractor draw bar, and therefore the victim used the front-end loader to lift the tongue. The chain was attached to the midpoint of the bucket edge and to the trailer tongue (see [Photo 2](#)). To be able to support the tongue and its supporting jack in the air, the loader had to be raised quite high, approximately 1.2 m (4') based on photographs from the scene after the injury.

The tractor did not have sufficient weight and traction to pull the trailer up the slope on snowy ground. The added tongue weight to the front bucket, combined with the slope of the ground transferred weight off the rear wheels
